# Field Testing of Concrete External Layer of Curtain in Poznan Large Panel System after 30 Years of Environmental Influences

Jozef Jasiczak, and Krzysztof Girus

*Poznan University of Technology, Poland*

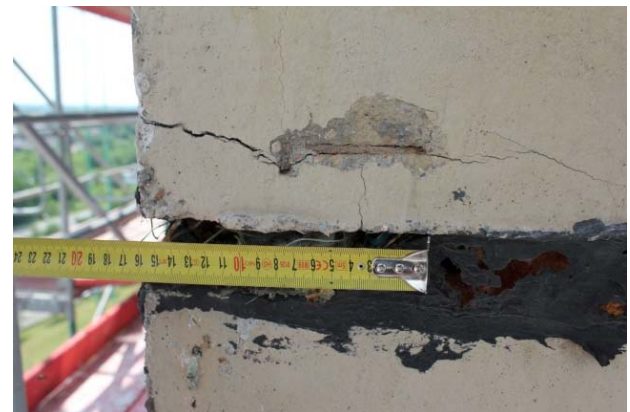
The end wall has definitely the greatest number of scratched panels — their share in that place is almost 80%. Local scratches are visible (or dispersed on the panel surface — Fig. 5) as often as the scratches going through the entire width or height of the component (Fig. 6). Scratchings of corners and edges also occur.

Fig. 5 Density of local scratches.

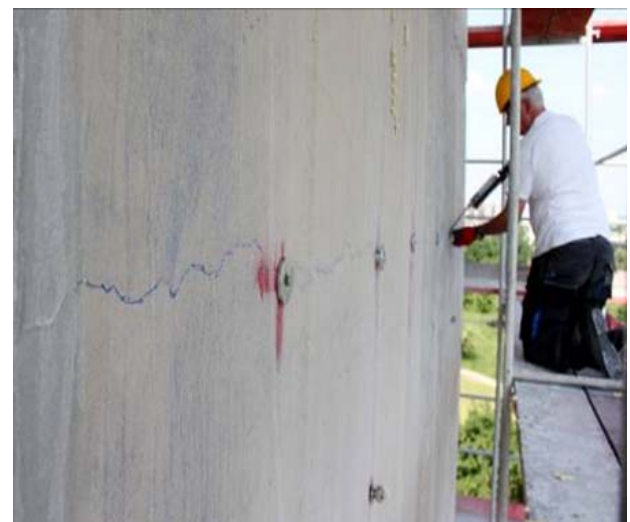
Fig. 6 Horizontal scratch, thickness of about 0.5 mm.

Therefore, actions aimed at reinforcing the external wall's anchoring and improving thermal efficiency of the external partitions seem to be necessary. These will additionally protect the curtain walls against further deterioration caused by the impact of weather conditions. However, the proposed chemical anchoring system may not be applied uncritically. Particular attention must be paid to the places, where the total thickness of the external and load-bearing layers exceeds 16 cm (in accordance with Table 2, over 26% of the tested panels). Due to minimum depth of anchoring and the maximum available length of the anchors, in the selected places, other connector system must be applied. Several verified panels did not meet the condition of minimum concrete grade — before executing the reinforcement, complementary tests must be conducted. The location of connectors in the scratched areas of the panels should be avoided as well (Fig. 6).

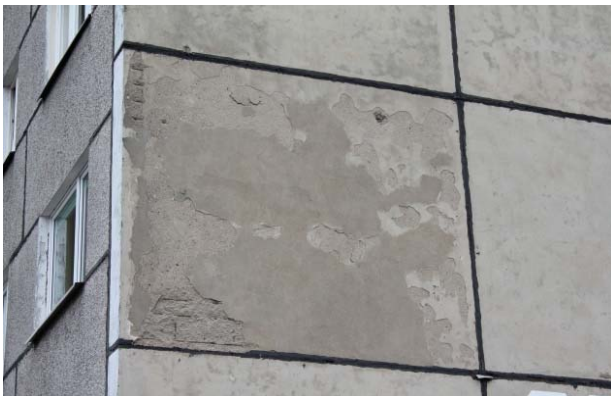
Another significant defect is visibly detaching grit, which is the finish of the external layer of the curtain walls. Almost 14% of panels has significant damages in this regard. It should be mentioned that grit covers only panels on the longitudinal wall. The end walls' finish is a painting layer (Fig. 7).

**Fig. 7 Degraded cardboard layer.**

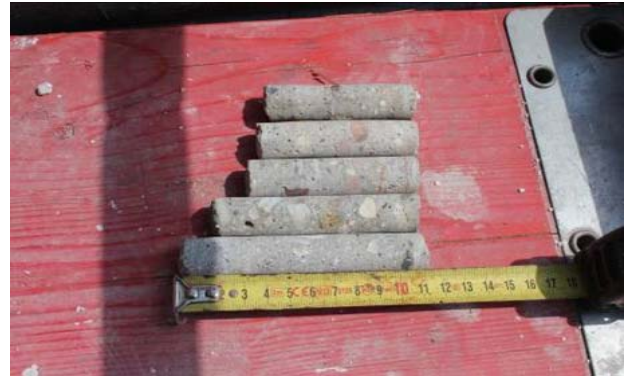
Significant deviations from the design assumptions were found also by measuring thickness of the external layer and the external layer and lagging in total. The thickness of the external layer for measured panels is from 4 cm to even 12 cm. For over 26% of panels, the total thickness for two layers is >16 cm. The listed deviations are adverse because the significant increase in the total thickness causes increase in the panel mass and the acting moment, which worsens the operation conditions of the steel hangers. Whereas the panel thickness of 4-5 cm is non-compliant with the requirements of the building construction (required min. 60 mm) [14] and may lead to significant decrease in the component durability (Fig. 8).

**Fig. 8 Variation of the layer thickness.**

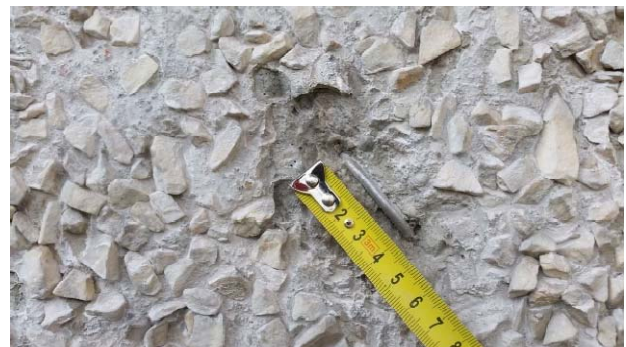
The last verified damage was detaching of the covering of hangers and pins, which may fasten the corrosion processes. The irregularities were found in the case of c. 5.4% of panels. The measured thicknesses of the covering in the detaching point varied in the range from 5 to 15 mm that is also below minimum requirements. However, it must be added that traces of corrosion (even of the surface one) were not found on any of the visible hanger rods. Among the pins, several of them were visibly corroded. The measurement of the hanger fragments confirms the application of the A0 steel (Fig. 9). Table 2 shows the summary of the survey results.

**Fig. 9 Visible steel pin.**

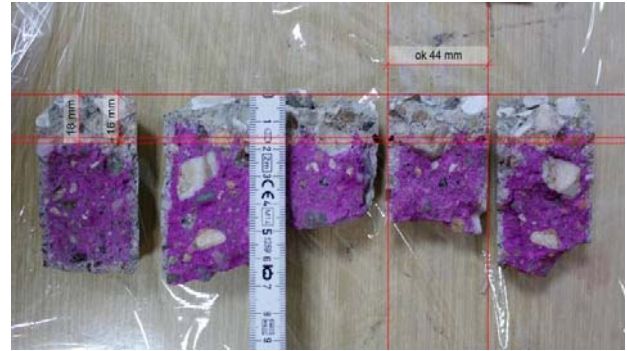
The maximum range of carbonation (18 mm) was measured. The attempt to determine the average range was also undertaken. Due to an uneven surface of the external layer and a significant share of grit in the surface layer, it is difficult to determine the depth precisely. However, it can be evaluated as c. 15-16 mm. Of course, the range of  $\text{pH} \geq 11.8$  (causing passivation of reinforcement) will be smaller than the coloured areas, which show  $\text{pH} \geq 9.0$ . The covering thicknesses measured in several places fluctuating between 5 and 15 mm allow to believe that both the pins and the hangers are exposed to initiation of the corrosion processes.

Fig. 10 Visualized analysis of the carbonation range of the external layer's concrete.

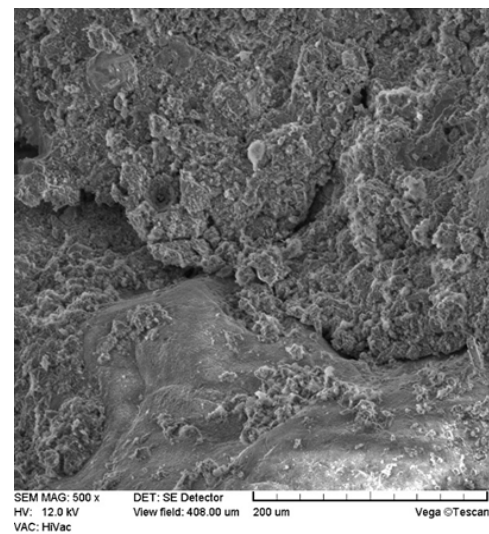
The figures show the concrete deterioration. Fig. 12 shows the ageing of the surface layer involving leaching the elements of Ca and Si (basic ingredients of concrete) increase in the content of elements of C, S and K (carbonation, acid rains).

Fig. 11 Texture of surface layer— concrete deterioration.

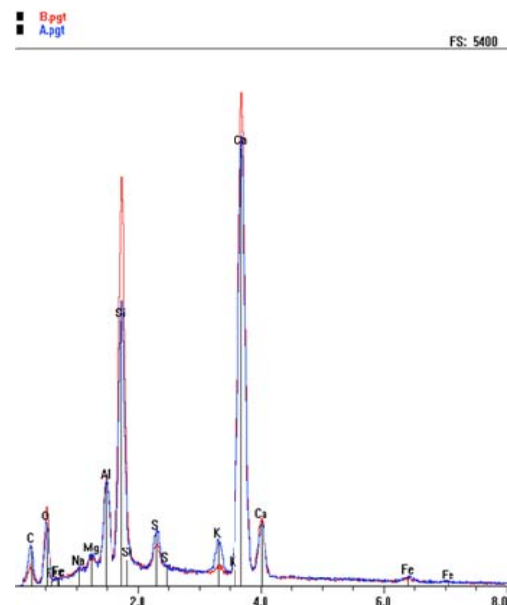
Fig. 12 Differences in XRD of the external (blue chart) and bottom layer (red chart).

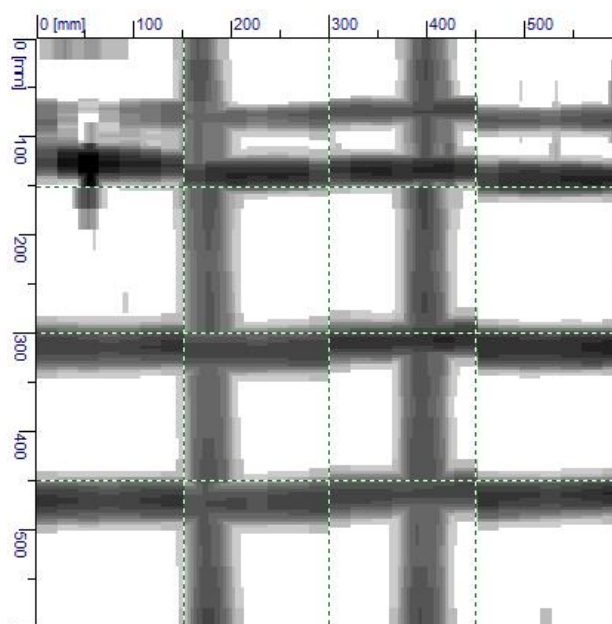
The analysis of the scanned images shows the application (in the external layer) a reinforcement mesh with even two-side spacing from 20 to 22 cm and the diameter of the rebars of 6-8 mm. Locally, the measurement shows the diameter of the bars of  $\phi 10$  mm but it may be a device's measurement error. The taken sample of the rebar confirms the use of smooth

**Fig. 15 Scan picture : 60× 60 cm image with a visible steel hanger (left top corner).**

steel A0 with the diameter of 6 mm. The covering of the reinforcement mesh on the measured components fluctuates in the range of 27-51 mm. In single places, the covering is min. 22 mm, which seems to be a favourable result anyway. Among measurements, there are also the ones showing significant, unacceptable deviations in the rebars arrangement — on the length of 120 cm, the axial spacing of the horizontal bars changes from 13 cm to 27 cm.
