Evaluation and Repair of Sinkholes in Qatar*

Jamal E M Al-Ansari¹, and Khaled E. Hassan²

1. Road Operation & Maintenance Department, Public Works Authority - Ashghal, Doha, Qatar

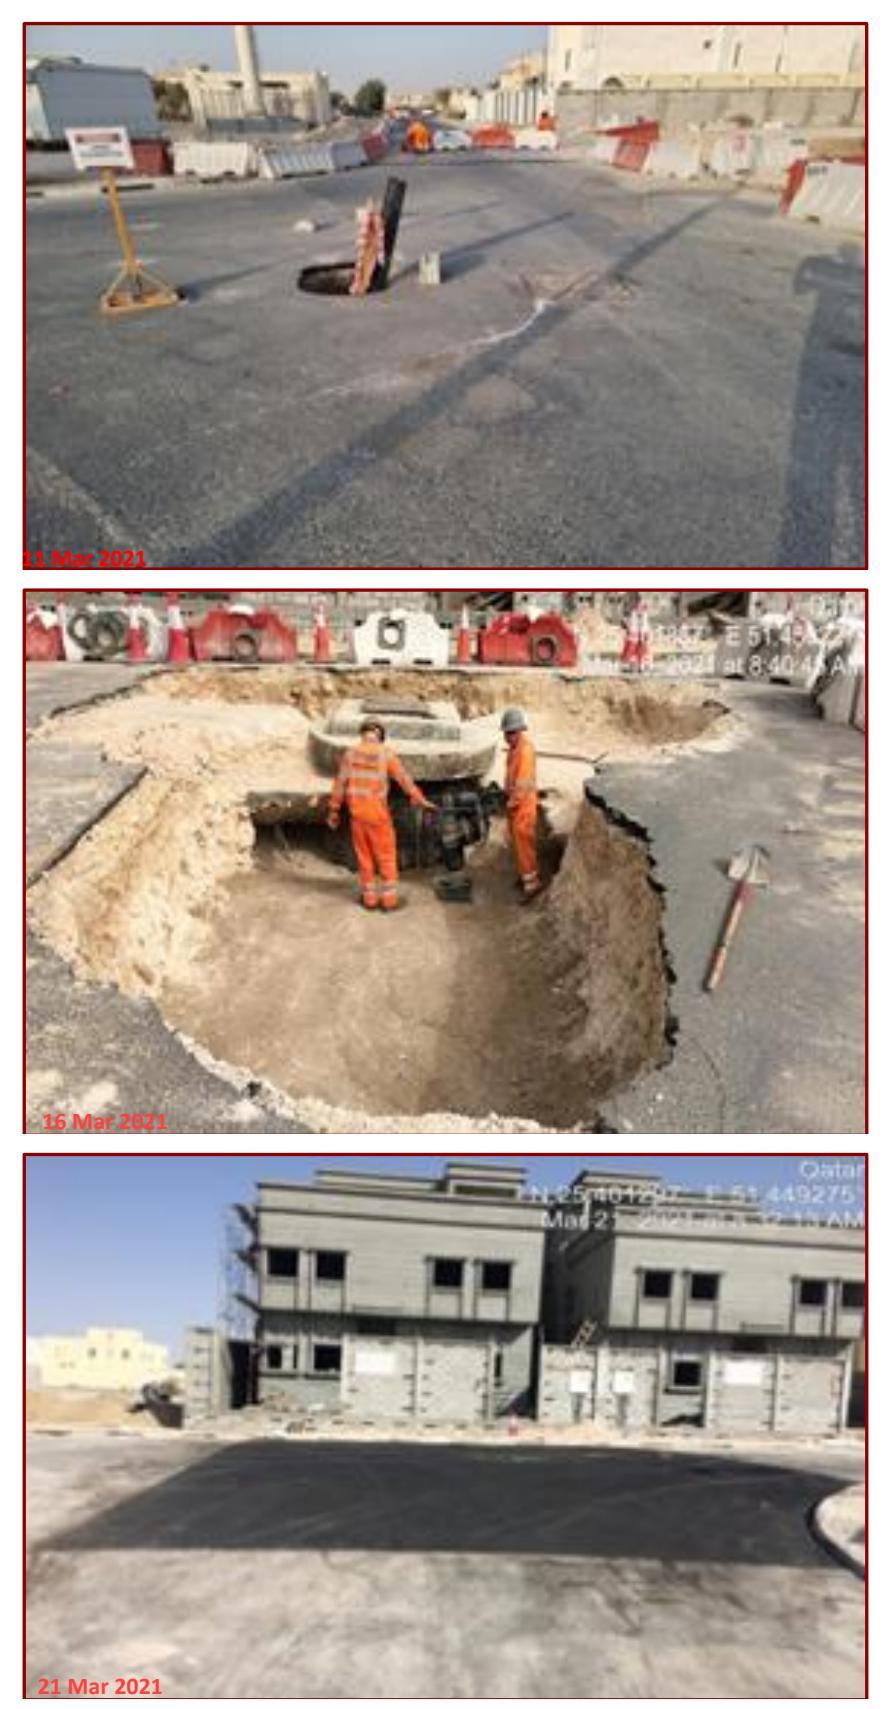
Fig. 5 Different stages of sinkhole evaluation and repair — Case Study 1.

Implementation of the Ashghal guidelines for the evaluation and repair of sinkholes commenced in late 2020, with more than 100 sites investigated over the last three years. Investigations revealed only shallow and medium sinkholes, caused mainly due to leakage of water or sewers. A case study is presented on the evaluation and repair of a sinkhole, which was reported at a residential area. The GPR investigation was initially performed, and the analysis indicated inconsistent layers of up to 0.8 m below the pavement surface, i.e., a shallow-depth sinkhole. The GPR investigation also indicated a wider area of the sinkhole than what the hole appeared at the surface. Fig. 5 shows the reported sinkhole in March 2021 with the surface hole detected near a manhole cover, together with the full area of sinkhole under the pavement surface. The cavity was due to the washing of poorly compacted materials around a manhole cover for the Surface Ground Water (SGW) pipeline, which was fixed before carrying out the pavement repair.

Excavation was conducted to remove all weak soil and erodible materials until a firm soil surface was reached. The bottom layer of the excavation was compacted to ensure a dense foundation support. A layer of Foamed Concrete (C5) was poured into the excavation hole and left to harden overnight before reinstating the pavement of unbound subbase materials and asphalt layers. The site was opened to traffic 24 hours after completion of repair and monitored periodically to assess performance under traffic and environmental loadings.

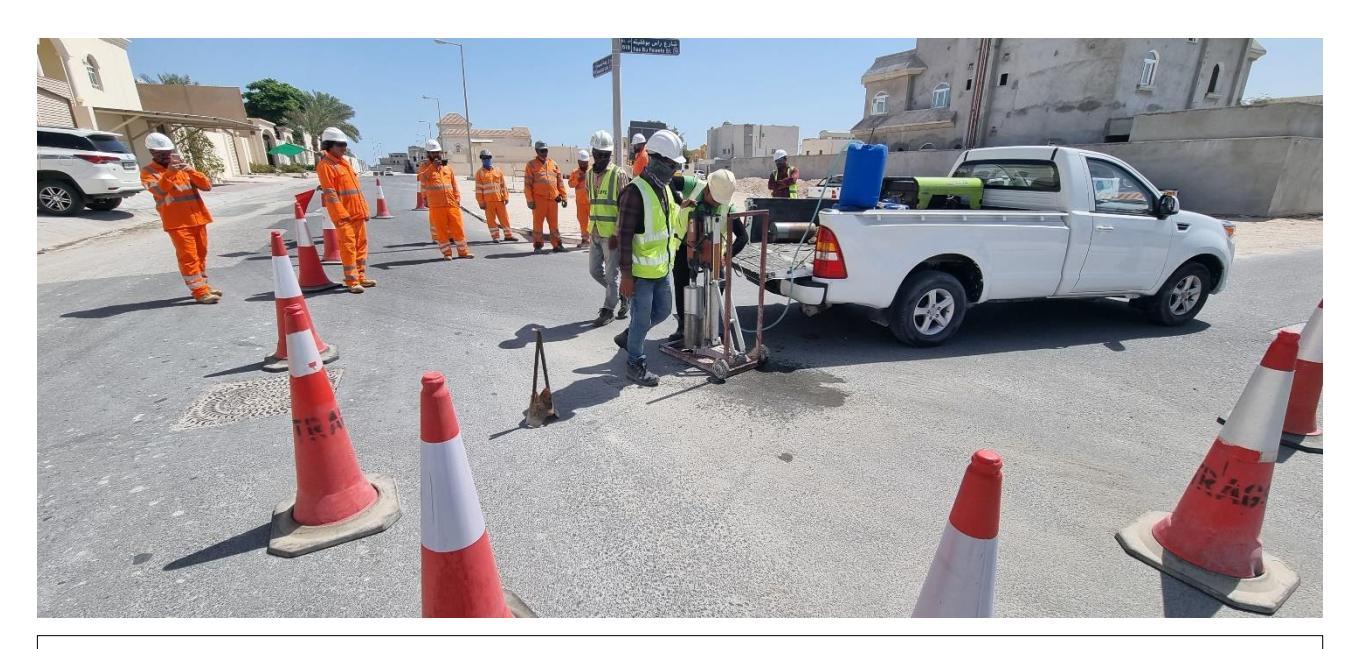
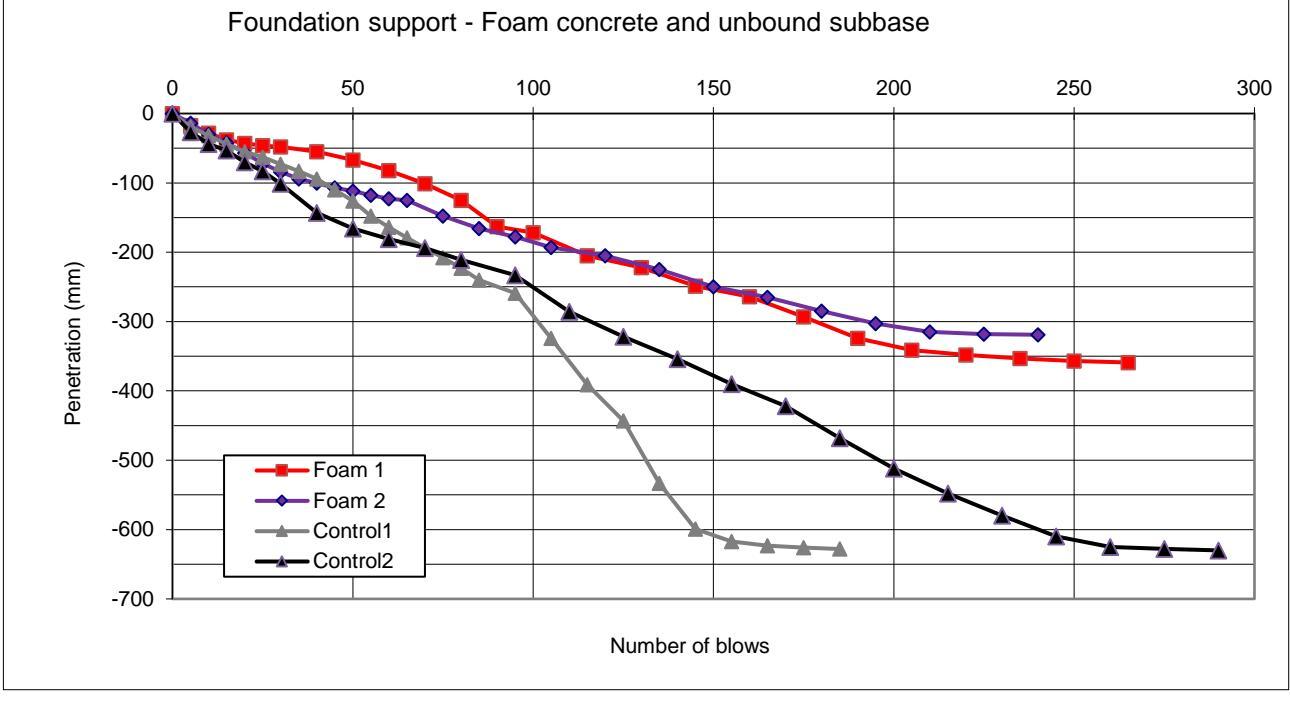
Fig. 6 Monitoring of the repaired site after 30 months in service.

No signs of depression or defects were observed up to the last monitoring date of January 2024, 30 months after repair. The pavement layers were intact with no evidence of surface or subsurface defects. The 3D-GPR results indicated consistent pavement layers around the manhole covers for the patched area. Cores were also taken from the repaired area, patch on top of foam concrete, and from the adjacent control pavement. Dynamic cone penetrometer (DCP) testing was conducted in the core locations, as per ASTM D6951 [9], and the results are shown in Fig. 6. The results indicate the foam concrete provides stronger foundation support, almost double the CBR value of the pavement foundation with the natural subgrade material.
