The Influence of Aerospace Infrastructure of the Amazon Region in Logistic Support to the Border Platoons of the Brazilian Army

Aron-Luis Martins da Silva, Flavio Neri Hadmann Jasper
(University of the Air Force, Brazil)

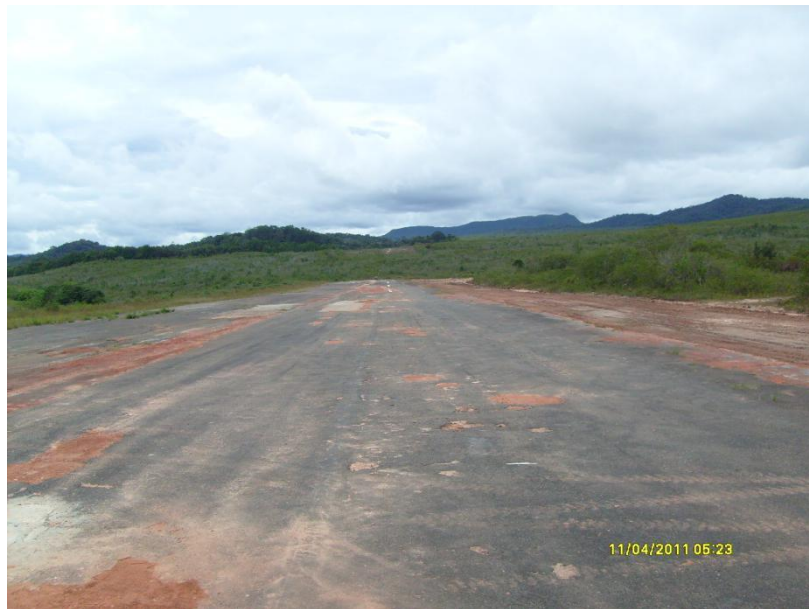
Photo 1 Surucucu's Airfield – RR.

In the Photo 1, it is possible to observe, in Surucucu's runway, holes, pebbles and other loose debris that can be ingested by the engines or hit by the propellers mainly during the application of the engines in reverse¹⁶ right after landing. There are also elevations around the runway, natural obstacles, which are relevant in the case of an operation in adverse weather conditions.

The type of pavement and, mainly, its state of conservation, are relevant data for the crew as planning factors. Of the eleven aerodromes studied, seven are made of asphalt, three are made of concrete and one is made of slate. In Photo 1, it is possible to observe that the runway pavement in Surucucu was compromised and, in a way, affecting operations in that location.

In addition to the type of the runways, the conservation of the strip pavement is also relevant information. Of the eleven aerodromes studied here, seven are made of asphalt, three are made of concrete and one is made of slate. Depending on the conservation of the pavement, it is possible to have pebbles and other loose debris, which can be ingested by the engines or hit by the propellers, mainly during the application of the engines in reverse right after landing. In this situation, the propeller blow is directed to the front, causing dust, sand and debris to accumulate on the pavement to be lifted, with occasional damage to the turbo-propeller assembly.

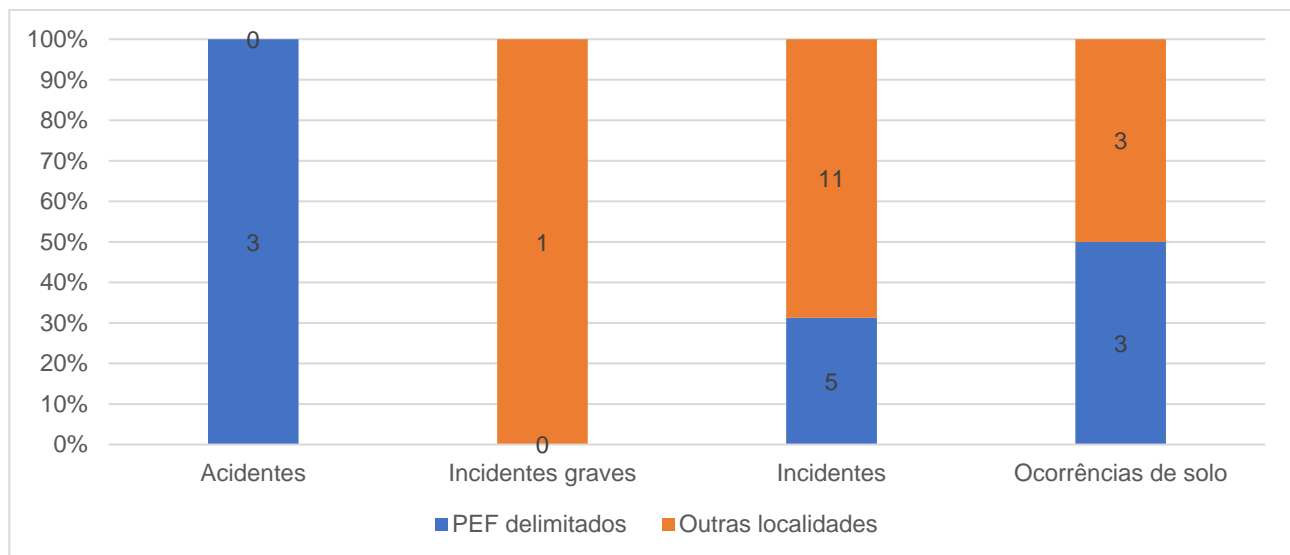
Figure 2 Aeronautical Occurrences - 2007 through 2018.

The statistics on aeronautical occurrences were sought to allow a comparison between the occurrences verified at the SBP aerodromes and other locations where the 1st/9th GAv operates. Figures 2 and 3 represent the data obtained.

It was found that 100% of accidents, 31% of incidents and 50% of ground occurrences were in the defined SBP, although the effective operation (in flight hours) did not reach 30%. These data reveal that, in the SBP, the number of events was lower in absolute numbers, but it was higher in percentage terms. It is also inferred that, in the delimited SBP, all the events that produced the most serious consequences (100% of accidents) occurred. The only serious incident recorded in the period, however, occurred in a location outside the defined SBP.

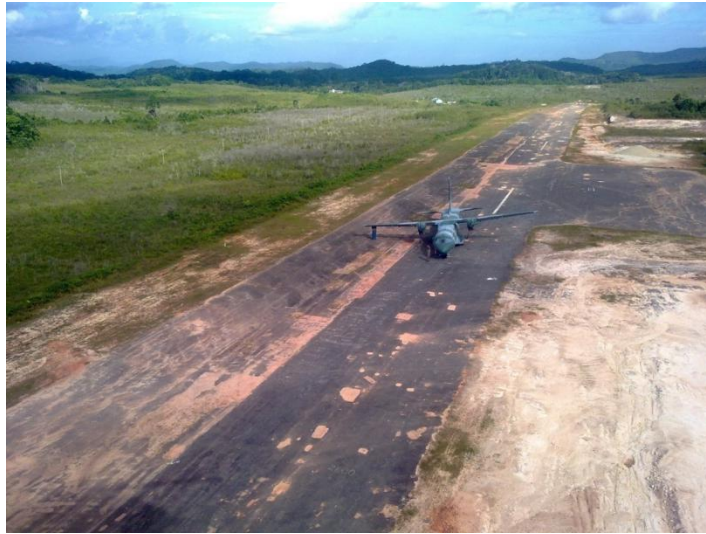
Photo 3 Aerial View of the Final Stop of the Aircraft.

The aircraft took off on Jan. 8.2011 bound for Boa Vista, SBBV, and from that location, it would make several “legs” for Surucucu (SWUQ) and Auaris (SWBV), transporting material and supply to CINDACTA IV, Army and COMARA. On the 13th of Jan.2011, in its second landing in Surucucu, transporting support material for COMARA, **the main right landing gear of the plane retracted involuntarily**. The accident occurred around 19: 00Z and the weather conditions were favorable. It was observed that, due to the poor maintenance of the track, **the pilots were operating on the left side, which was the least bumpy side**. (Author's bold).

With the Aerospace Infrastructure as a focus, of the relevant aspects raised and analyzed, it is clear that, at the time, only one side of the runway was used for landing, the one with the least holes, which reduced the dimensions to 1080 m × 15 m. Through Photo 3, there is a wide view of the available width of the track, of the holes in all extension, the elevations nearby the airfield and a part of the unevenness between the runway headlands.

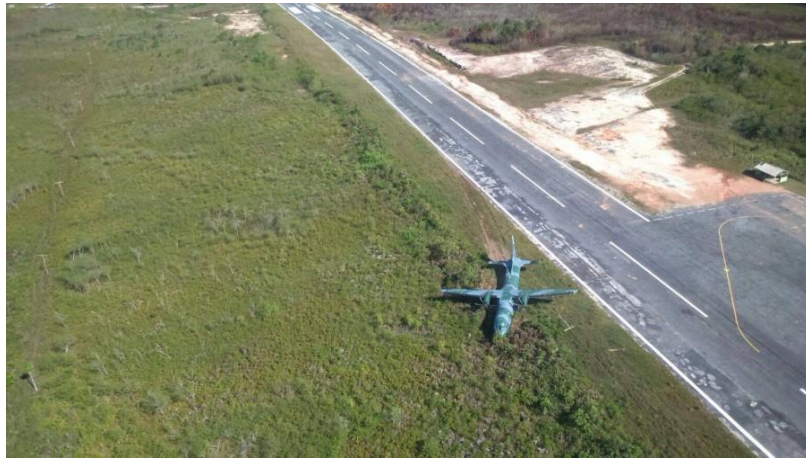
Photo 4 Aerial View of the Accident - Surucucu

At 12:40 pm (local), the aircraft took off from the Aerodrome of Boa Vista, RR (Atlas Brasil Catanhede - SBBV) bound for the Aerodrome of Surucucu, RR (Alto Alegre - SWUQ), with 06 (six) crew members on board, in order to carry out the transportation of fuel drums and a passenger. During the final approach to SWUQ headland 30, **the aircraft touched before the runway in use. The main landing gears collapsed and the lower fuselage crashed into the ground.** The aircraft sustained substantial damage [...]. (Author's bold).

The circumstances involved in this accident were similar to what happened in 2011, in the same location, differing only in the extent of the structural damage that was more serious because there was an exit from the runway. Due to the severity of this accident, until the year 2019, the aircraft was still in Surucucu. It had only been towed to the parking lot.

After extensive studies by those responsible for the equipment, it was concluded that the recovery of the aircraft is economically unfeasible. In this way, it will be dismantled and removed gradually²². The spare parts that were in good condition were reused in other aircrafts.
