The Preservation and restoration Project of the Castello dei Paleologi in Casale Monferrato (Alessandria): The Works on the External Wall Surfaces of the Northern Bastions

Giorgia Gentilini

Key words: bastions, brick, restoration, maintenance

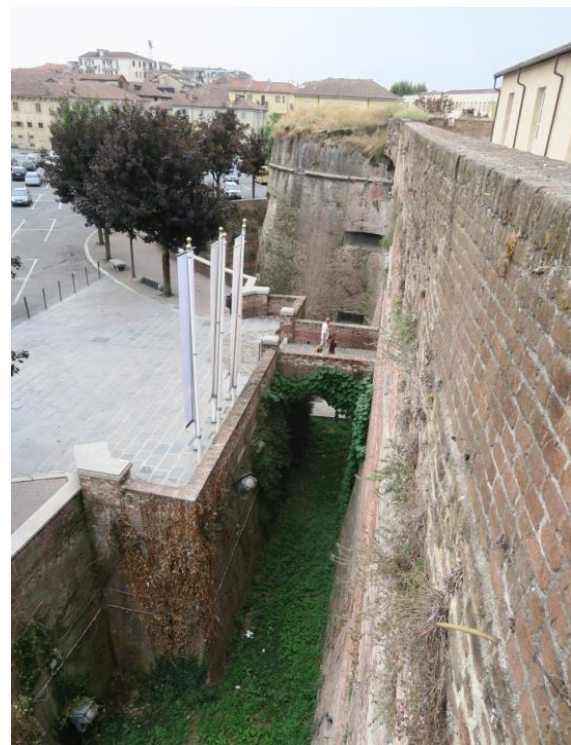
Fig. 1 View from the north of the south-east bastion, of the eastern curtain and of the counterscarp of the moat.

The Eastern front of the fortified system, which is the object of the intervention, heads towards the urban core of the historical centre, for which it represents a prestigious backdrop. The eastern prospect is almost 84 meters long, of which 37.5 meters for the central curtain wall and 23 meters each side for the two bastions closing it to the north and to the south: the height of the curtain and of the bastions varies between 14.5 and 15 meters.

coping diameter about 20 meters. The wall thickness varies between 6.5 and 8 meters. The thickness of the eastern central curtain is inferior, 3.85 meters. The boundary walls feature an inclined scarped profile, particularly marked in the bastions. The brickwork support structure is separated from the coping with the battlements of the parapet by a rounded cordon made from sedimentary stone: the curtain instead features a brickwork cordon closing the scarp and a rectangular profiled cordon reconnecting with that of the bastions. The wall curtain, in its articulated stratification, is a good evidence of the size and complexity of the continuous changes the Castle has been undergoing in the course of time. In particular the eastern front houses the main entrance to the fortification which retains some traces of its XV century look. The access to the first inner court (the most ancient core) is defined by a round-arched portal with a frame in relief made from brickwork elements and featuring two coat of arms, the bigger of the two showing the arms of the Gonzaga and Paleologi families and the smaller the ancient arms of the Gonzaga family. Above the entrance portal the lifting system of the drawbridges is still well visible, featuring huge housings for the beams for the main entrance and for the small entrance door of the pedestrian passage, to the right of the main door. Inside the walls two square adjacent courts are present, separated by a central corridor developing towards north-south.

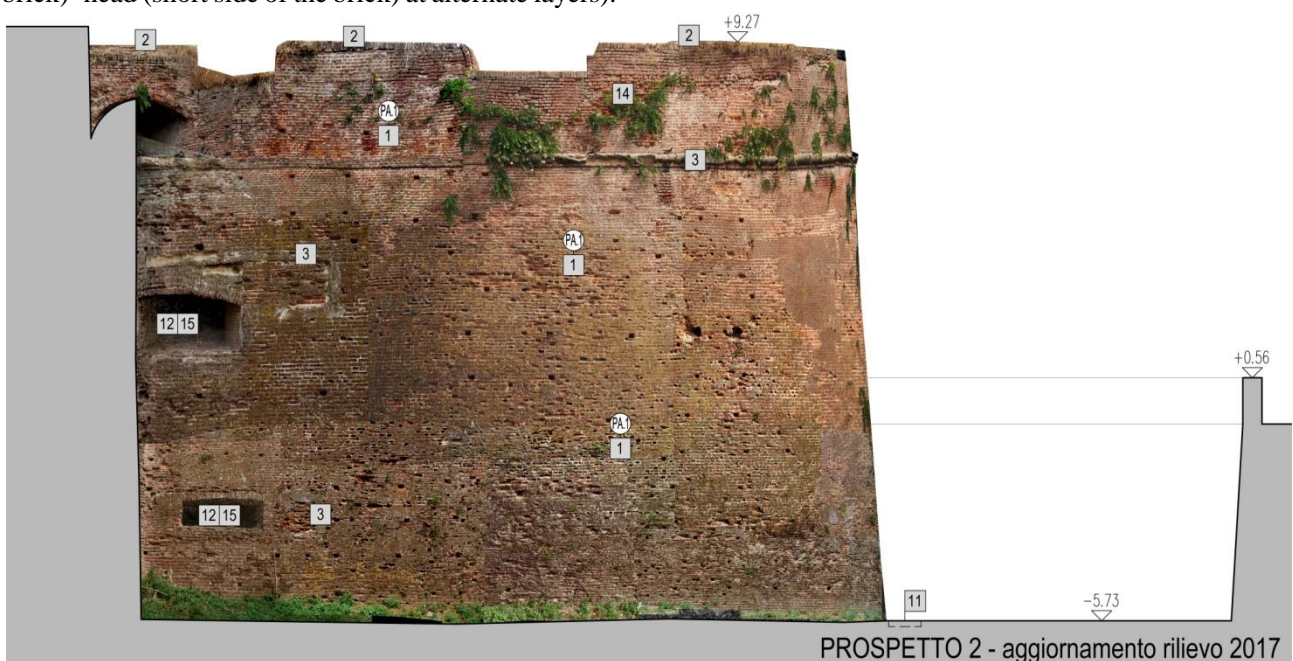
Fig. 2 Project table of the north-east bastion with counterscarp of the moat.

In order to prevent the vegetation with roots to get nearer to the prospects with brick face of the south-east bastion, of the eastern curtain, of the north-east bastion, a 90cm. wide stripe of gravel flooring is foreseen after mechanically lowering the soil by 15 cm.

Other reintegration works of the wall continuity are considered necessary for the abutments of the gunboats of the terraces of the Eastern bastions, now not fully visible due to the presence of soil and massive weeds. Accurate take-off and put-on operations are much needed for diverse portions of the top coping of the two bastions above the shaped cordon where the wall disaggregation looks worrisome. The areas where the pigeons rest will be possibly reduced by filling the bridge holes and the bombers/gunboats through a copper net duly shaped and fixed on the frames. The resulting material, not dangerous but not reusable, will be duly disposed of in an authorised damp.
