# Field Testing of Concrete External Layer of Curtain in Poznan Large Panel System after 30 Years of Environmental Influences

Jozef Jasiczak, and Krzysztof Girus

*Poznan University of Technology, Poland*

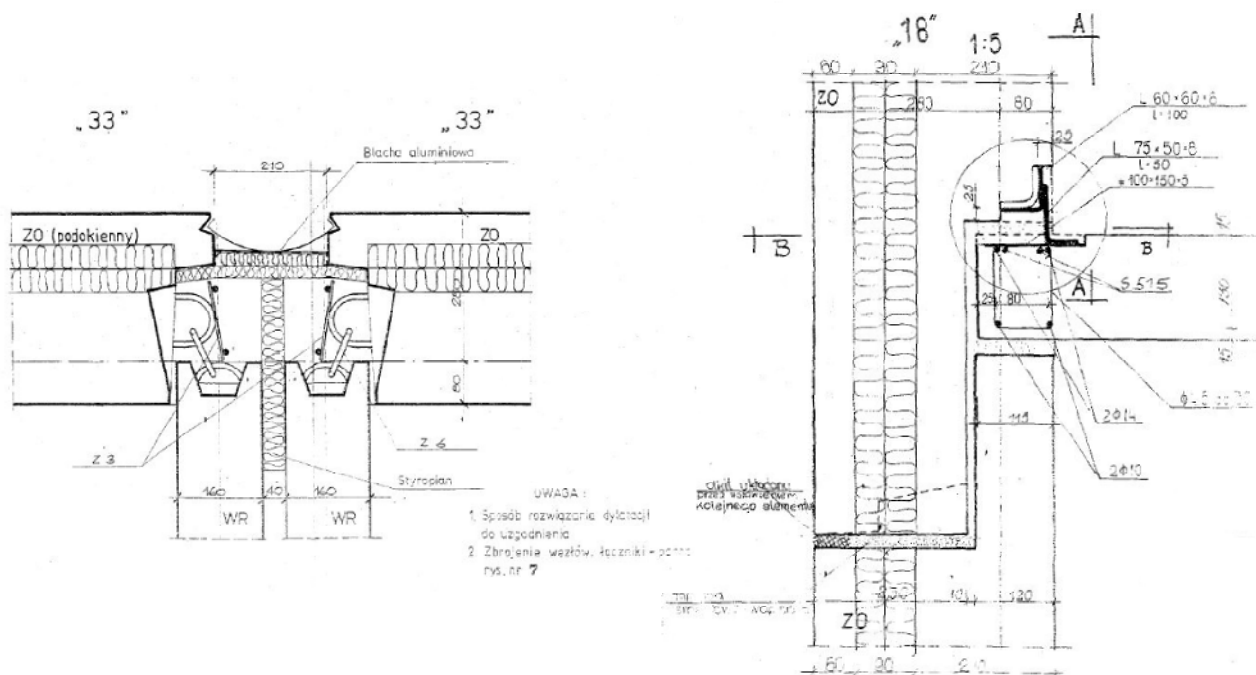
**Fig. 1** Sections through a triple-layer curtain wall [10].

projected thicknesses of particular layers are respectively: 6 cm (concrete exterior cladding layer anchored using pins and hangers with the load-bearing layer), 9 cm (insulation layer made of mineral wool), and 21 cm (structural layer).

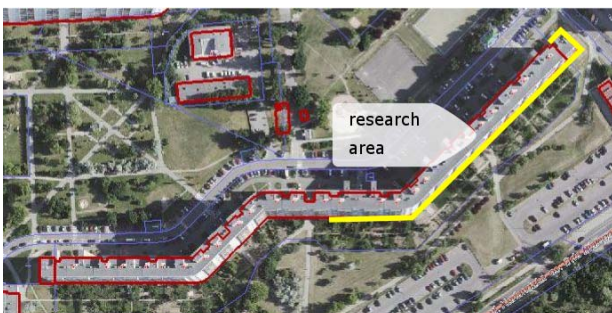
Fig. 3 Illustrative photo — top view of the building [13].

The survey of the façade and further tests were coordinated with the conducted works on thermal efficiency improvement. Therefore, the area of interest was restricted to the fragment of a wall with extra loggias and an end wall with two rows of panels on the frontal façade (Fig. 3).

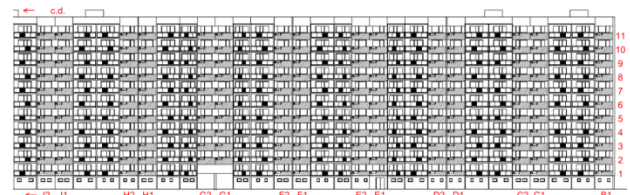
Fig. 4 Section of the façade fragment with panels divided into sections [9].

The façade panels, for the needs of the survey, were divided into 30 sections along the building. Each section consisted of 11 panels of particular floors (Fig. 4).

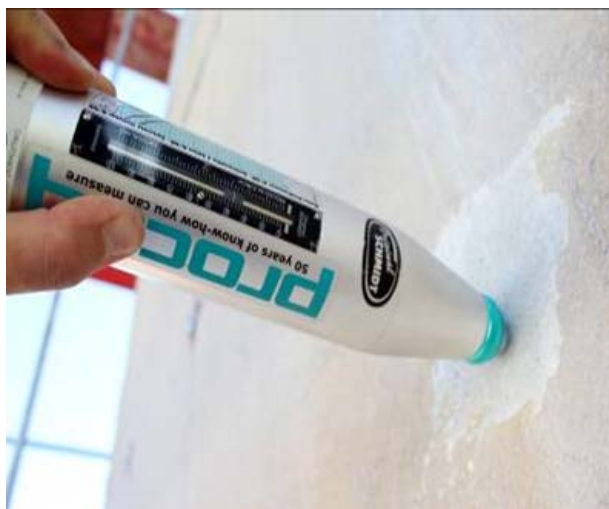
to the tested surface. On each component, 9-12 measurements were conducted in 6 places (Fig. 13). Table 3 summarises the calculated characteristic strength  $f_{ck}$  for 13 tested panels of the external layer. The results were generated in the N Schmidt hammer\EU PRO v.3.80 software. Significant differences in the measurement may result from conducting the test on the component that was not rigid enough. According to the recommendations, the minimum thickness of the component should be 100 mm. Moreover, the specifics of the external layer involve its suspending from the load-bearing layer, which additionally lessens the rigidity. Hence, the part of the ram's energy was used for component vibrations.

**Fig. 13** Measurement of the L rebound number on a smooth surface of an end wall.

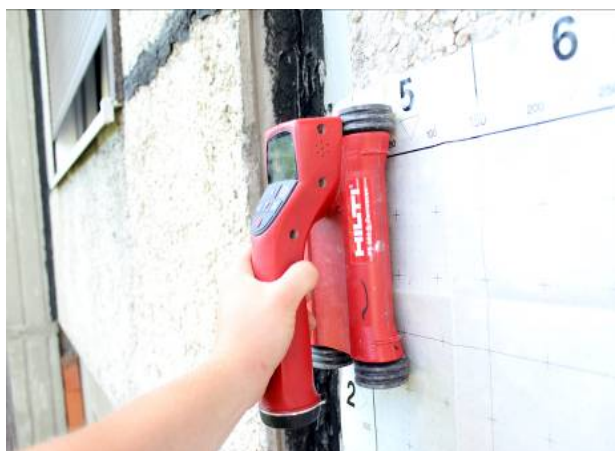
By using the Ferrosan PS200 ferromagnetic device by Hilti, an approximate location, a diameter, and a covering of the external layer's reinforcement (Fig. 14) were specified. The measurement was conducted in accordance with the device's user manual [18].

The analysis of the scanned images shows the application (in the external layer) a reinforcement mesh with even two-side spacing from 20 to 22 cm and the diameter of the rebars of 6-8 mm. Locally, the measurement shows the diameter of the bars of  $\phi 10$  mm but it may be a device's measurement error. The taken sample of the rebar confirms the use of smooth

**Fig. 14 Scanning the reinforcement with the Ferrosan PS200 device.**
