Evaluation and Repair of Sinkholes in Qatar*

Jamal E M Al-Ansari¹, and Khaled E. Hassan²

1. Road Operation & Maintenance Department, Public Works Authority - Ashghal, Doha, Qatar

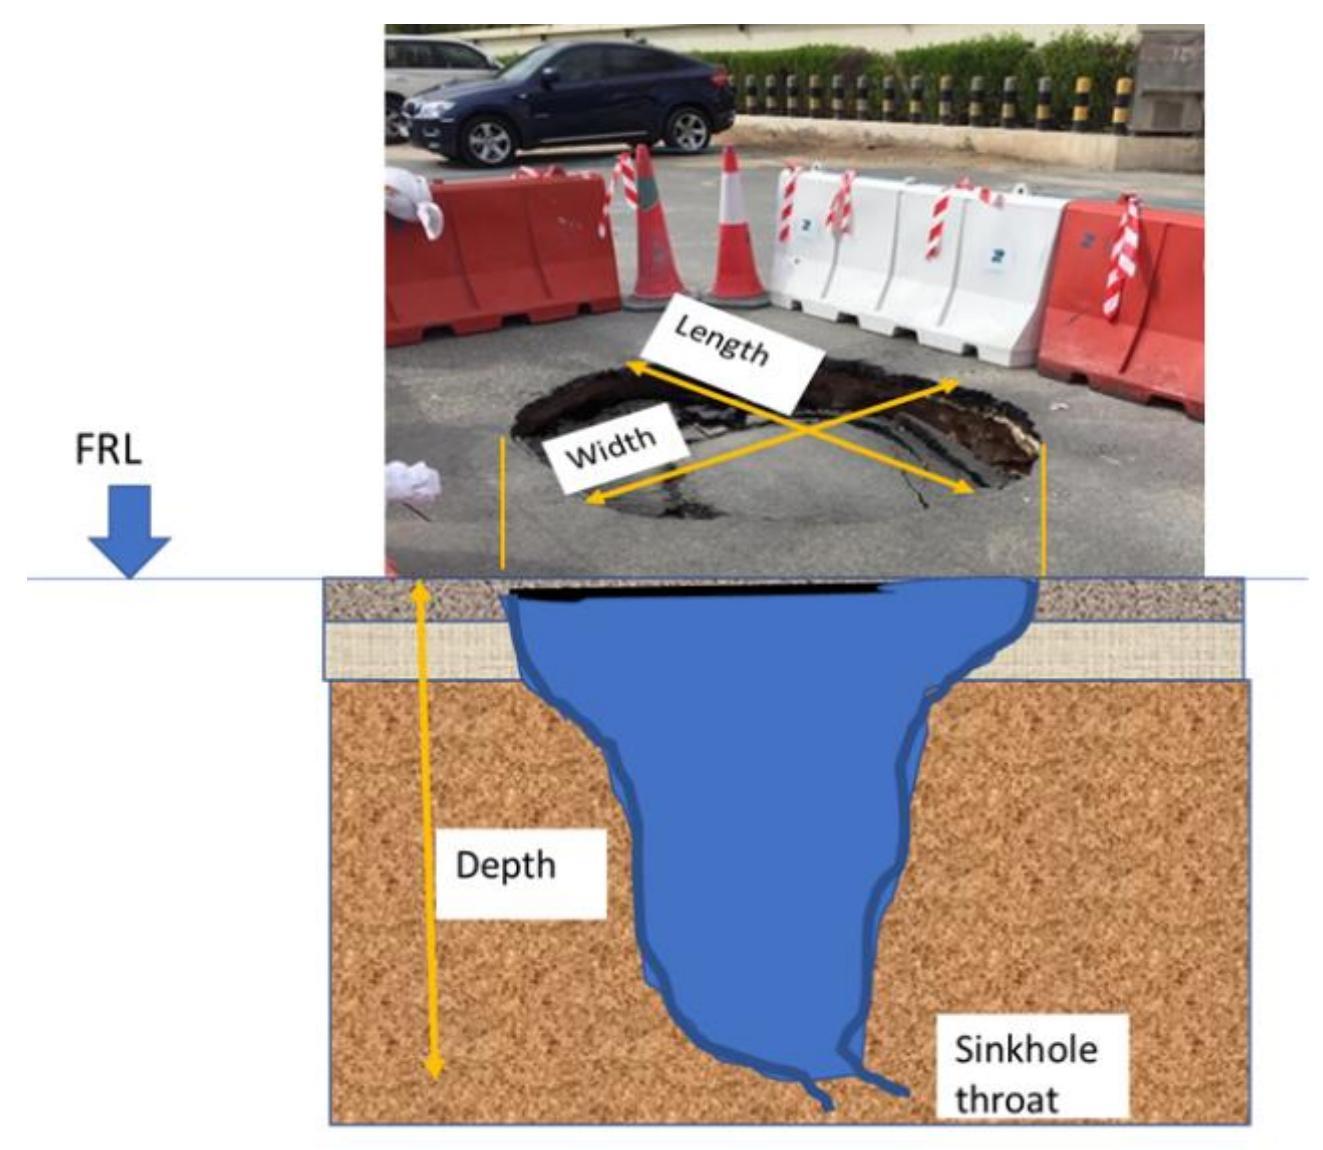
Fig. 3 Measurement of sinkhole dimensions.

Sinkholes are generally circular in plan with a funnel shape, where the wide end opens at the surface and the narrow end is at the bottom. The depth of a sinkhole refers to the depth from the pavement surface (Finished Road Level, FRL) to the bottom of the sinkhole, as shown in Fig. 3. For repair purposes, the ROMD manual classifies sinkholes into shallow, medium and deep as given below:
